Re: Mesquite Power, LLC - CEC Decision No. 63232

Comprehensive Land Management Plan Annual Status Report Mesquite Power Project

November 2002

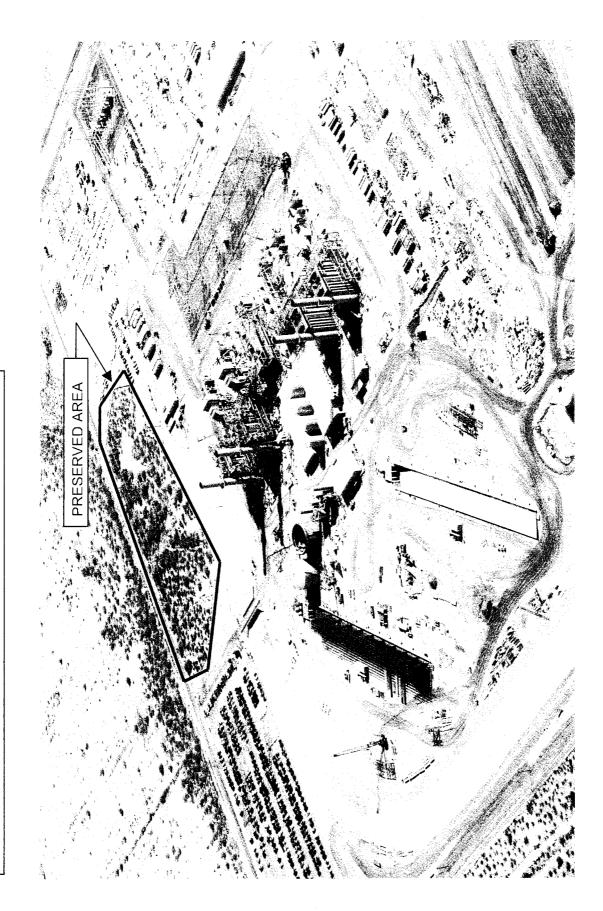
PLANT SITE - AERIAL PHOTOGRAPH

The three areas of the plant site that were identified as preserved, have remained undisturbed during construction and will remain undisturbed during operations. These three areas have significant mesquite bosque and are valuable to both wildlife and as a visual screening. These three areas are identified on the aerial photographs provided in Attachment A. These areas have been fenced with orange snow fencing to provide additional protection. In addition, an area south of the west evaporation pond did not have to be cleared and has remained undisturbed. Mesquite Power, LLC will attempted to maintained this area in its natural state for the remainder of the construction period.

PRESERVED AREAS SOUTHERN PORTION OF SITE

PRESERVED AREAS NORTHERN PORTION OF SITE

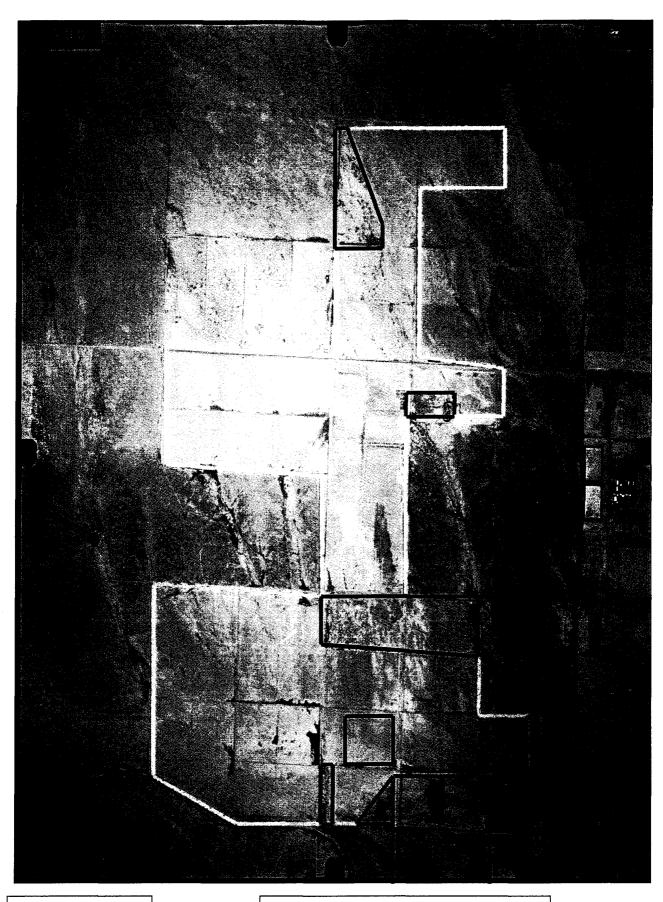
WATER PROPERTY LAND ASSESSMENT

The 3,000 acres of water property was classified into the following six categories with a brief description of each provided. Further study and review of the water property resulted in a revision of the amount of acres in each of these categories that was described in detail in the November 2001 Status Report. There have been no significant changes to these classifications and the estimated acreage for each category is presented below. An aerial photograph of the water property with the areas for each category highlighted is provided in Attachment C. (Note that the aerial photograph does not show the entire property. The property extends to the south approximately ½ mile south of Centennial Wash. None of this property requires re-vegetation. There is an approximate 140-acre parcel east of the property that may require some re-vegetation based on how the natural re-vegetation proceeds.)

50 AC TEST PLOT

LAND NOT REQUIRING RE-VEGETATION

PARTIAL RE-VEGETATION

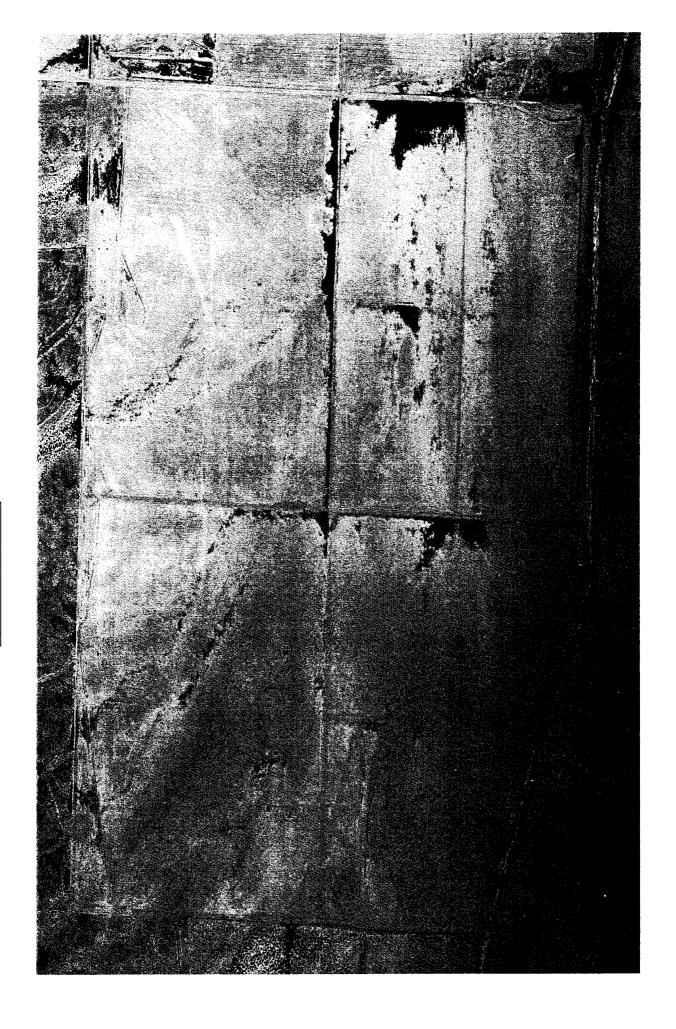
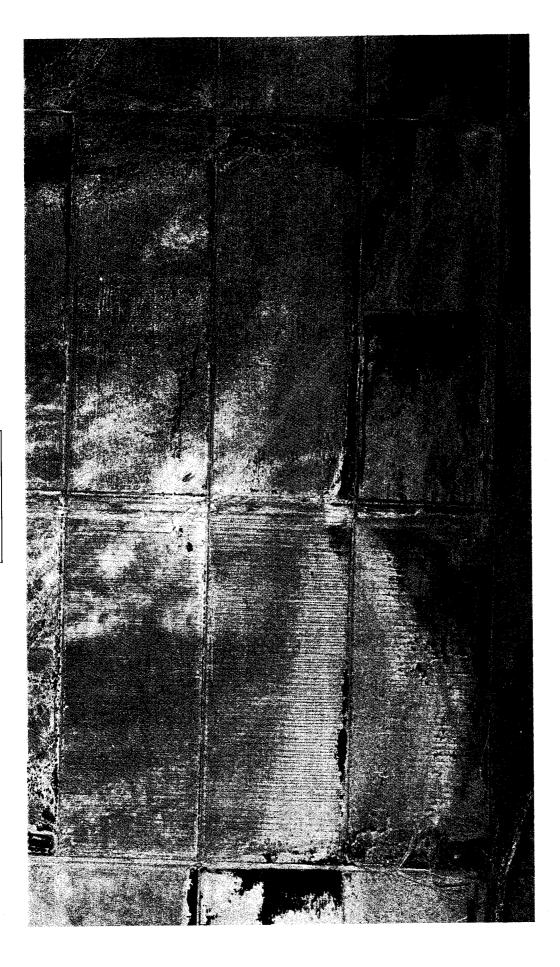
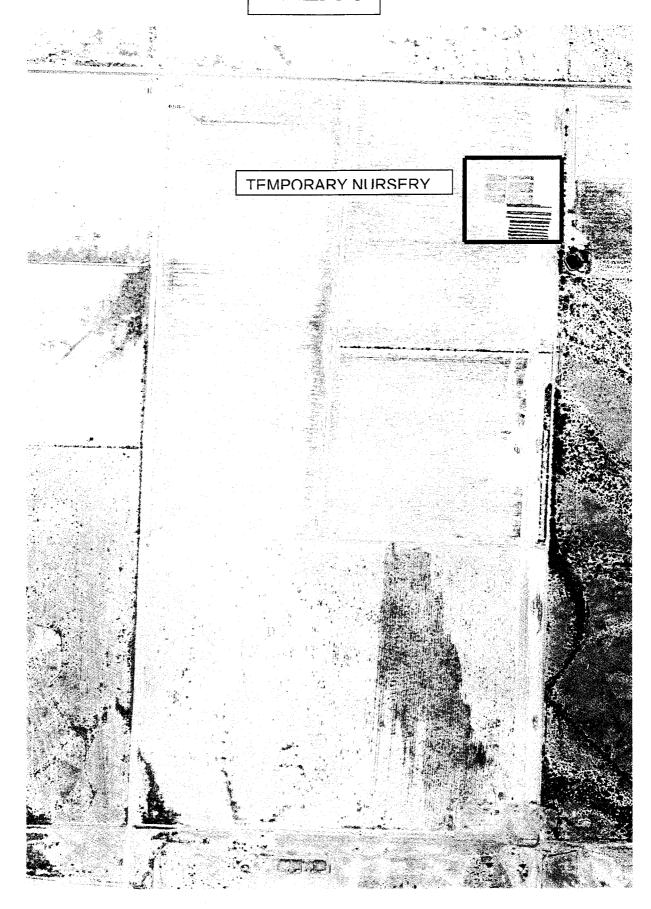
ATTACHMENT G Water Property – Re-vegetation Areas

The re-vegetation program will focus on re-vegetating the areas with the list vegetation and included Sections 24 and 13 in Range 7 west and Sections 18 and 19 in Range 6 west. These areas have been identified as Areas 1,2, 3 and 4. An aerial photograph designating these areas and a close-up photograph of each area is provided in Attachment G. Mesquite Power, LLC will re-vegetate between 200 and 265 acres of Area 1 in late February or early March 2003. The remaining portions of Area 1 will be re-vegetated in early 2004.

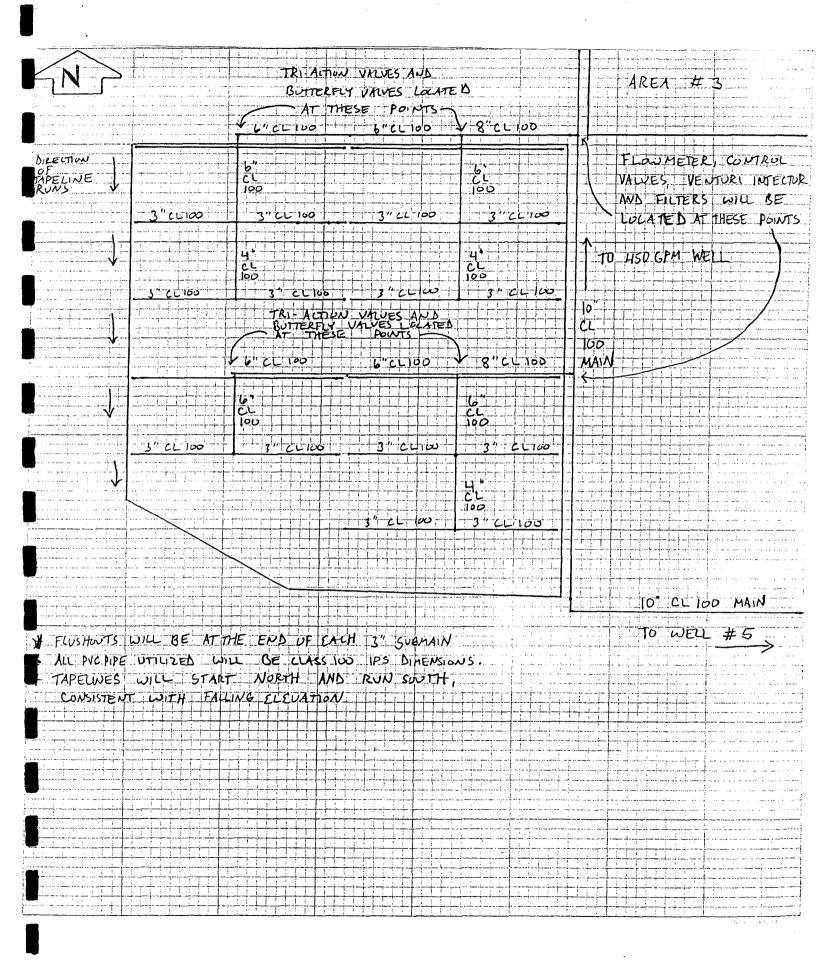
ATTACHMENT I Irrigation System

Plants for this re-vegetation effort were ordered during the summer with a list of the plants and quantities provided in Attachment H. The irrigation system materials have been ordered and installation will begin in December 2002. The piping system is being set-up to be used for Areas 1, 2, 3, and 4 so that significant irrigation work is not required in the future. The drip irrigation system for the 2003 planting will be installed have the main system is completed. A sketch of the system is provided in Attachment I.
